Town of Rowley

Bridge Inventory Evaluation

JUNE 2019

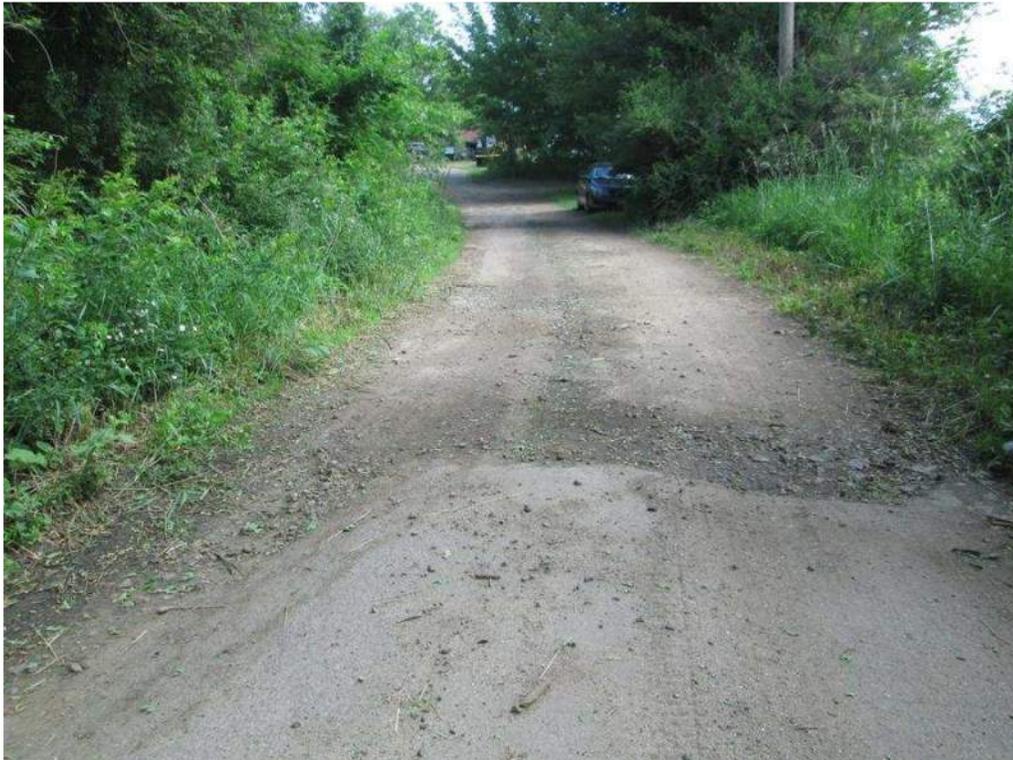
Photo 6: North Approach (Looking North) at End of Bridge Pavement Gravel Potholes

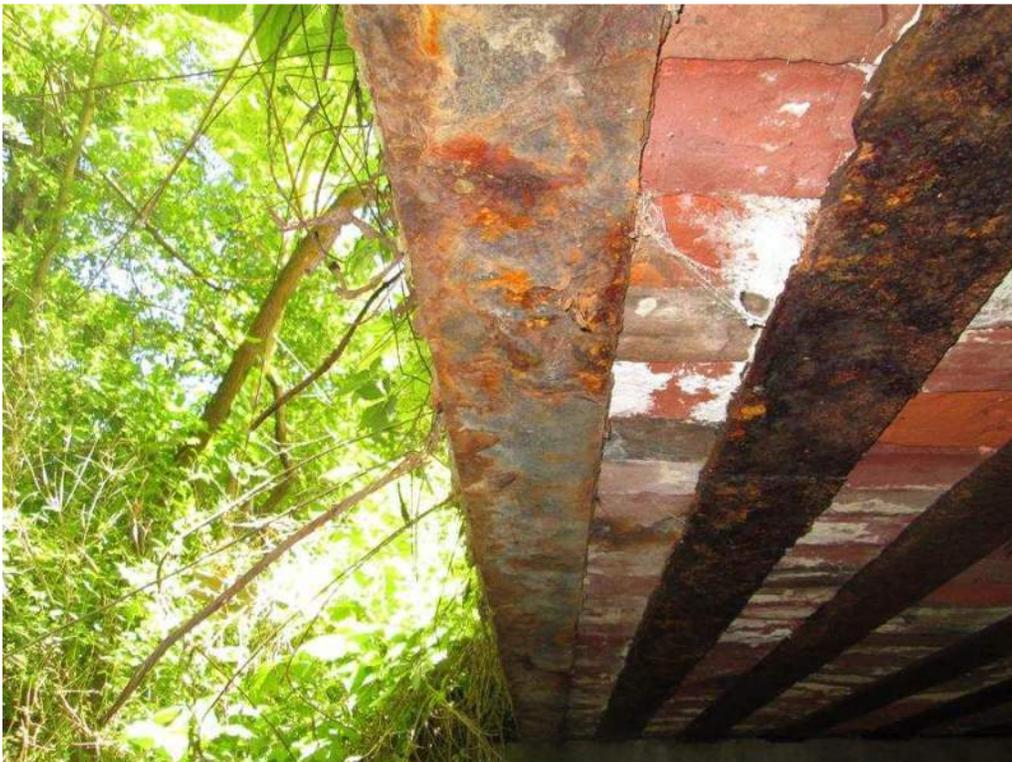
Photo 8: West Fascia Rail R-1 Bottom Flange Typical Span Heavy Rusting

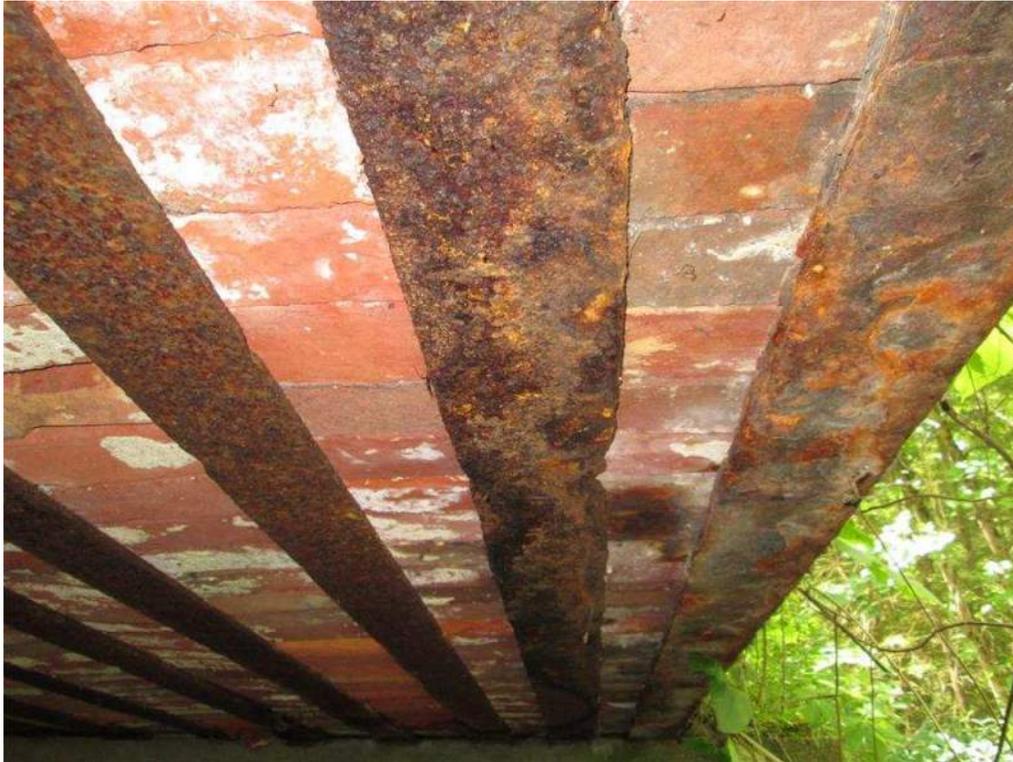
Photo 9: Rail R-2 Bottom Flange Typical Span Heavy Deterioration

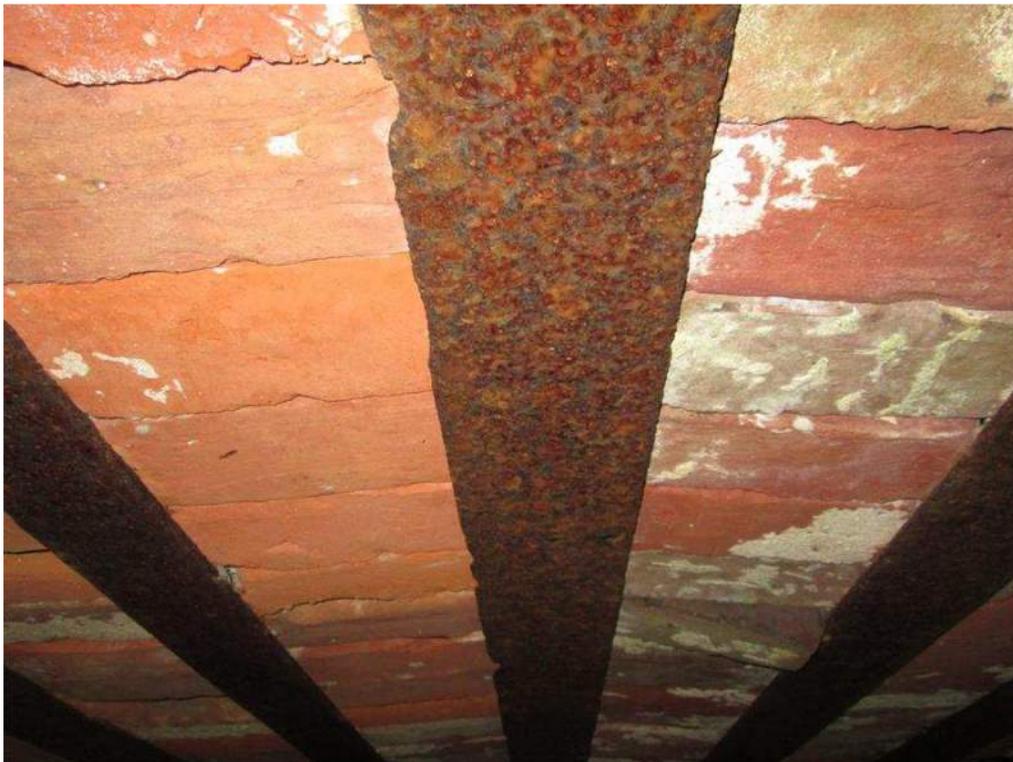
Photo 10: Rail R-5 Bottom Flange Typical Span Surface Rusting

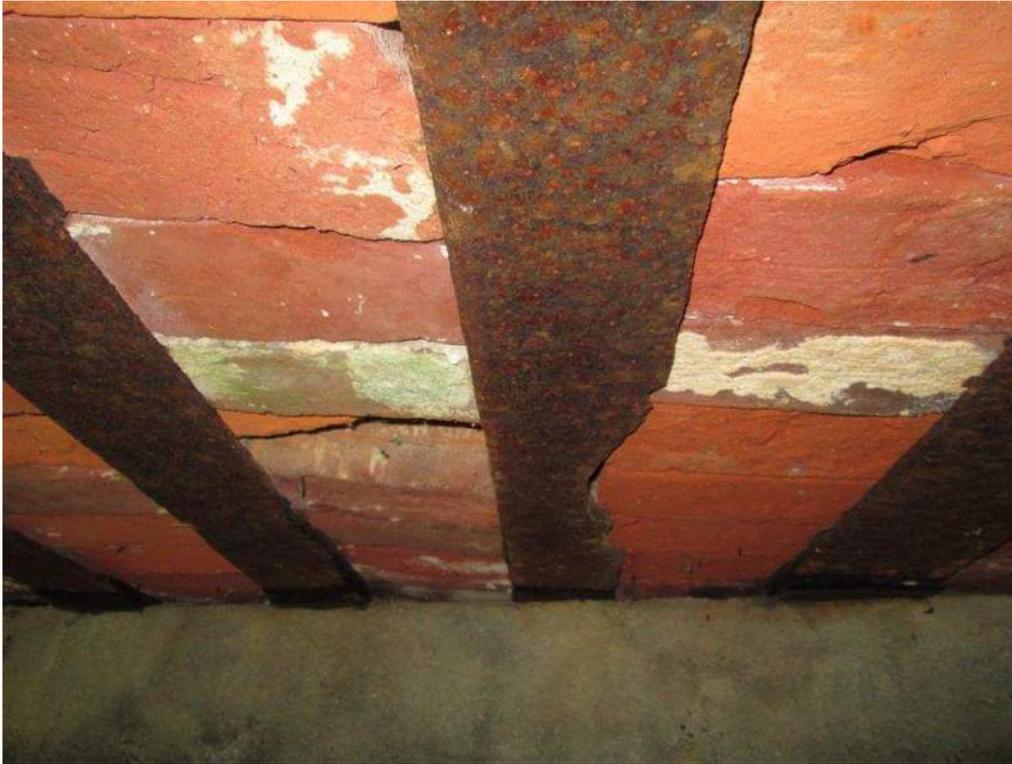
Photo 11: Rail R-6 Bottom Flange Typical Span Surface Rusting and Notched Area

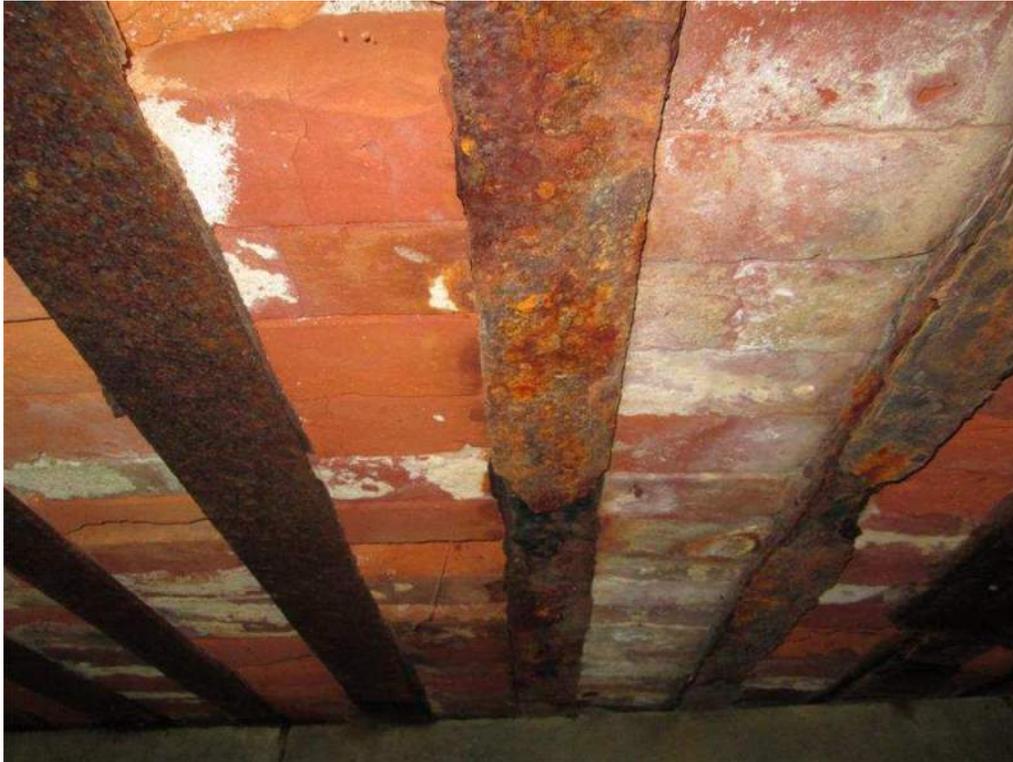
Photo 13: Rail R-10 Bottom Flange Typical Span Heavy Deterioration

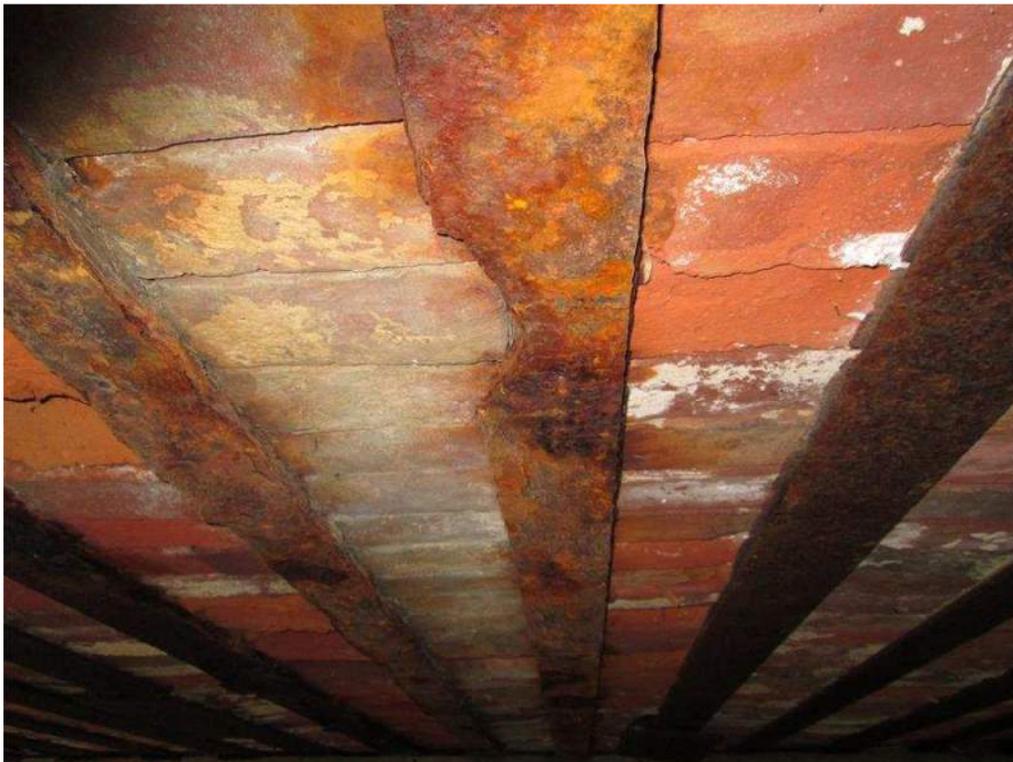
Photo 14: Rail R-10 at Midspan Bottom Flange Partial Loss of Section

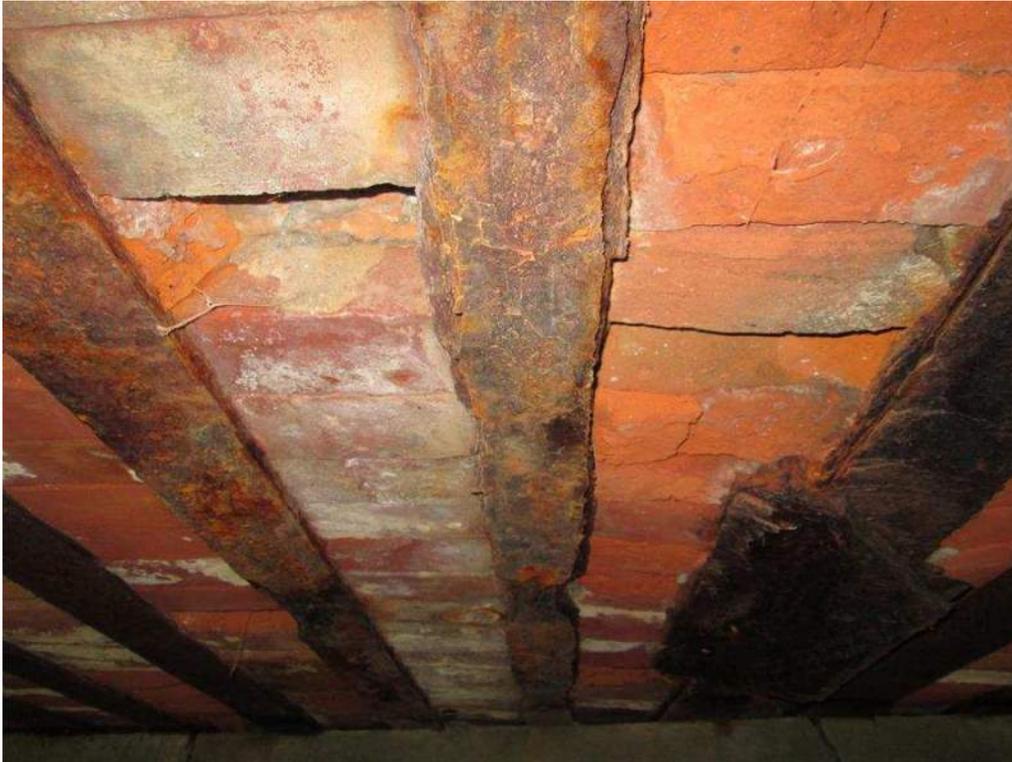
Photo 15: Rail R-11 Bottom Flange Typical Span Heavy Deterioration

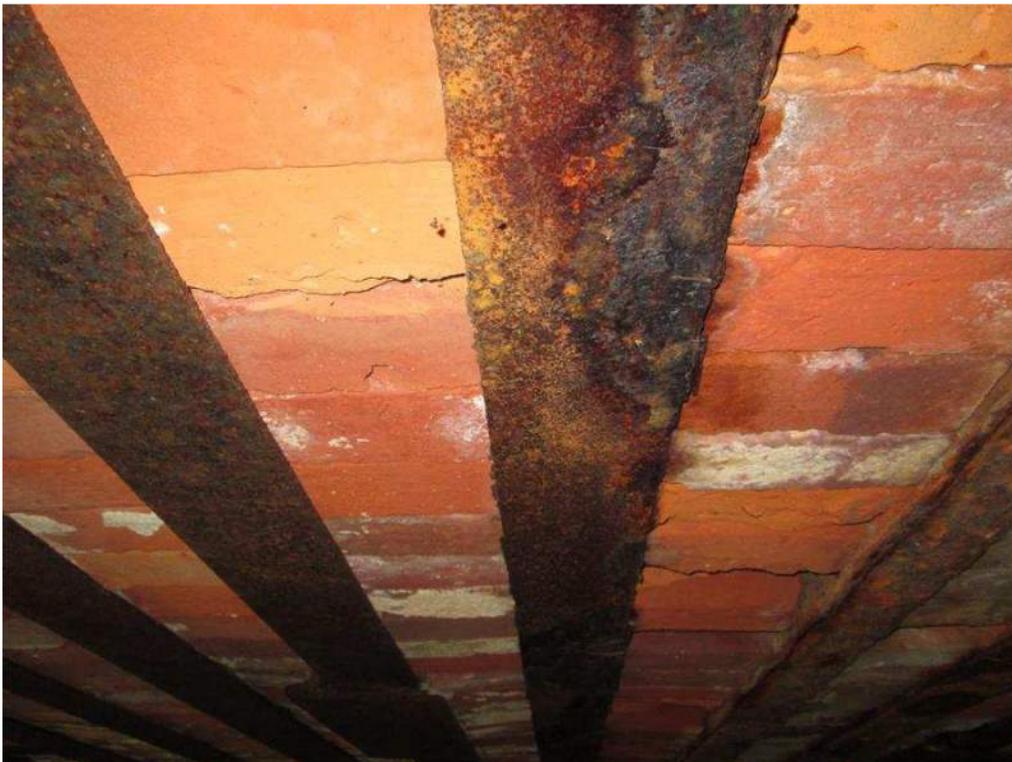
Photo 16: Rail R-12 Bottom Flange Typical Span Heavy Deterioration

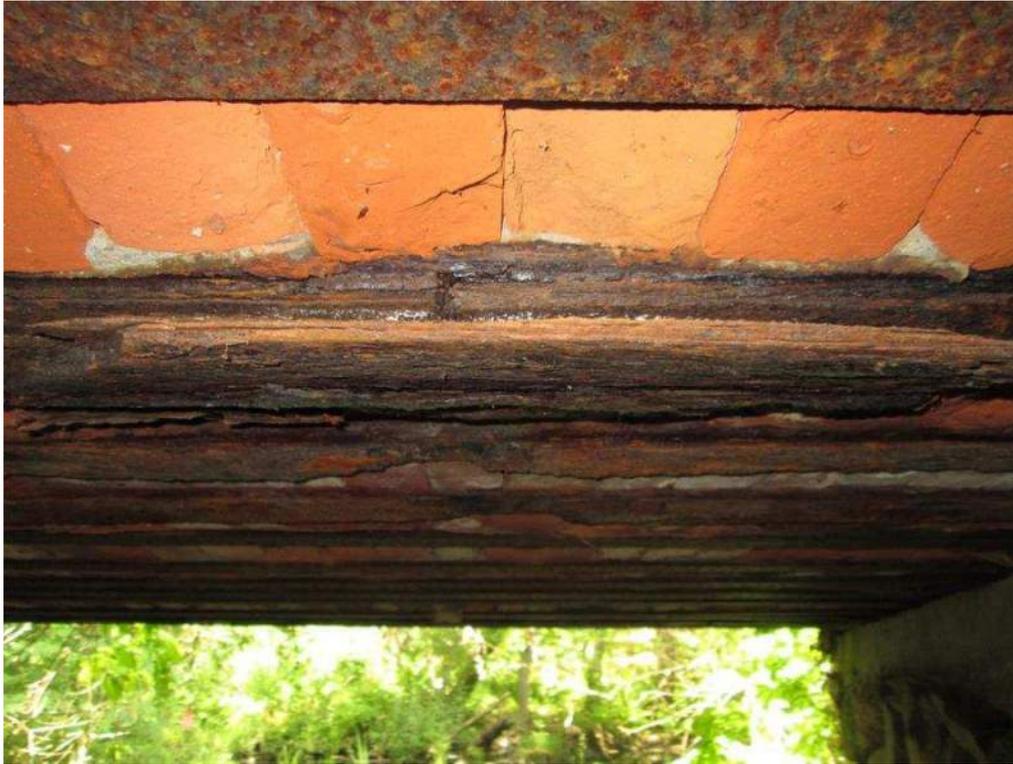
Photo 17: Rail R-12 at North End Bottom Flange Splice and Heavy Deteriorated Splice Plate

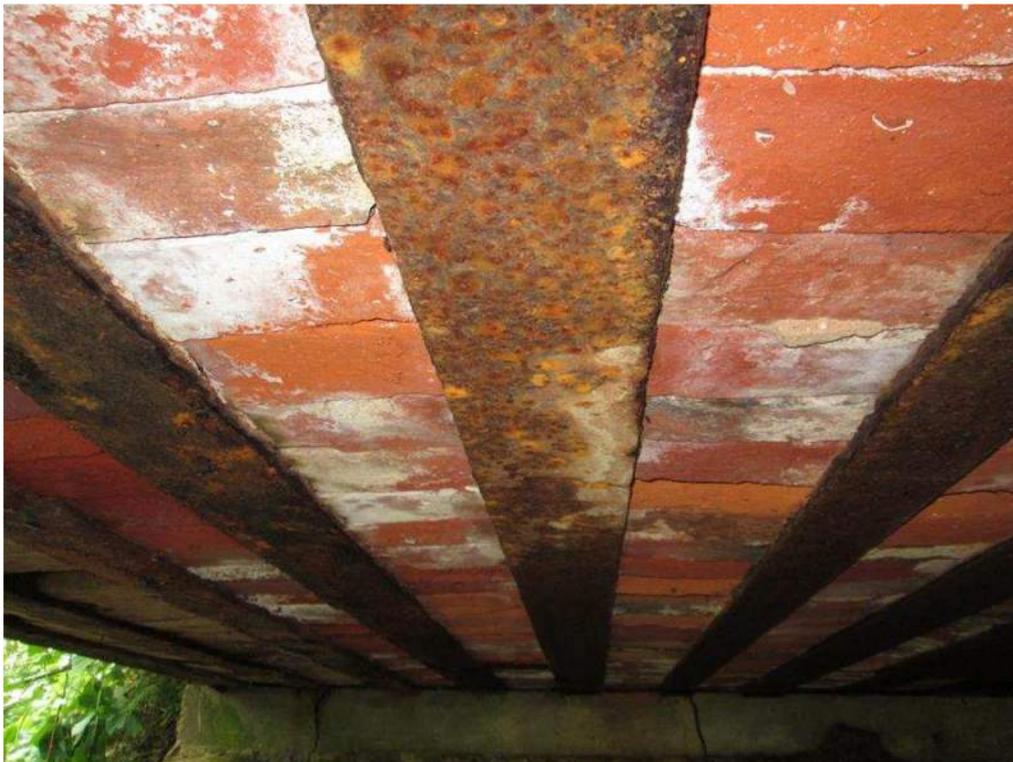
Photo 18: Rail R-16 Bottom Flange Typical Span Surface Rusting

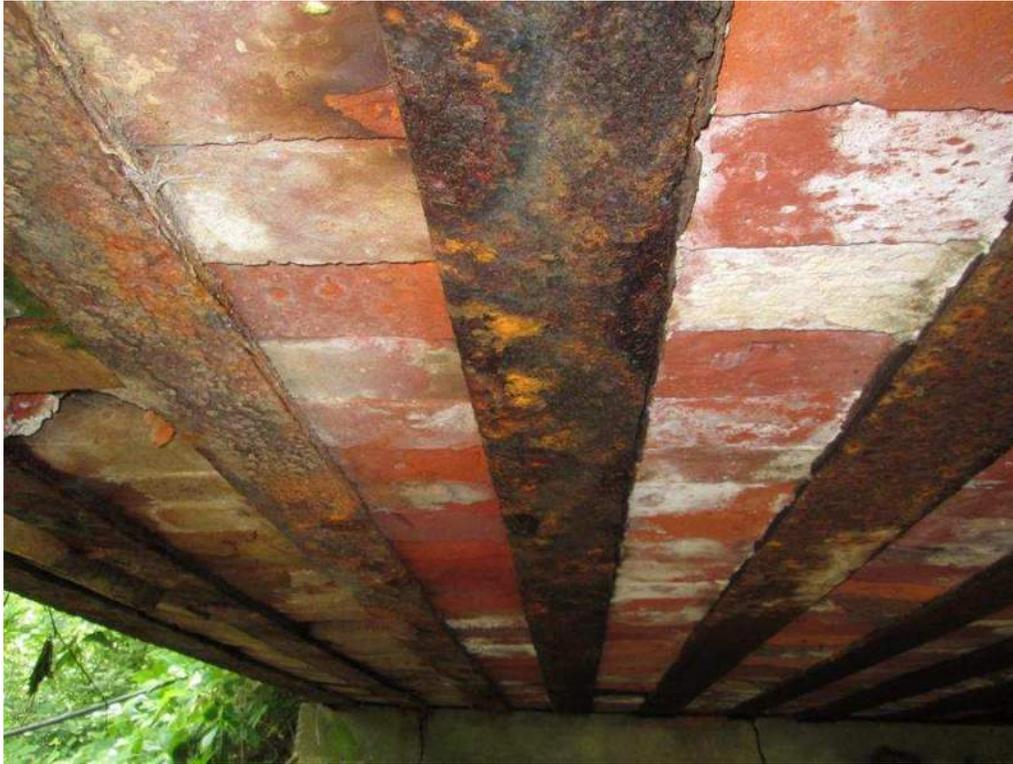
Photo 19: Rail R-17 Bottom Flange Typical Span Heavy Deterioration

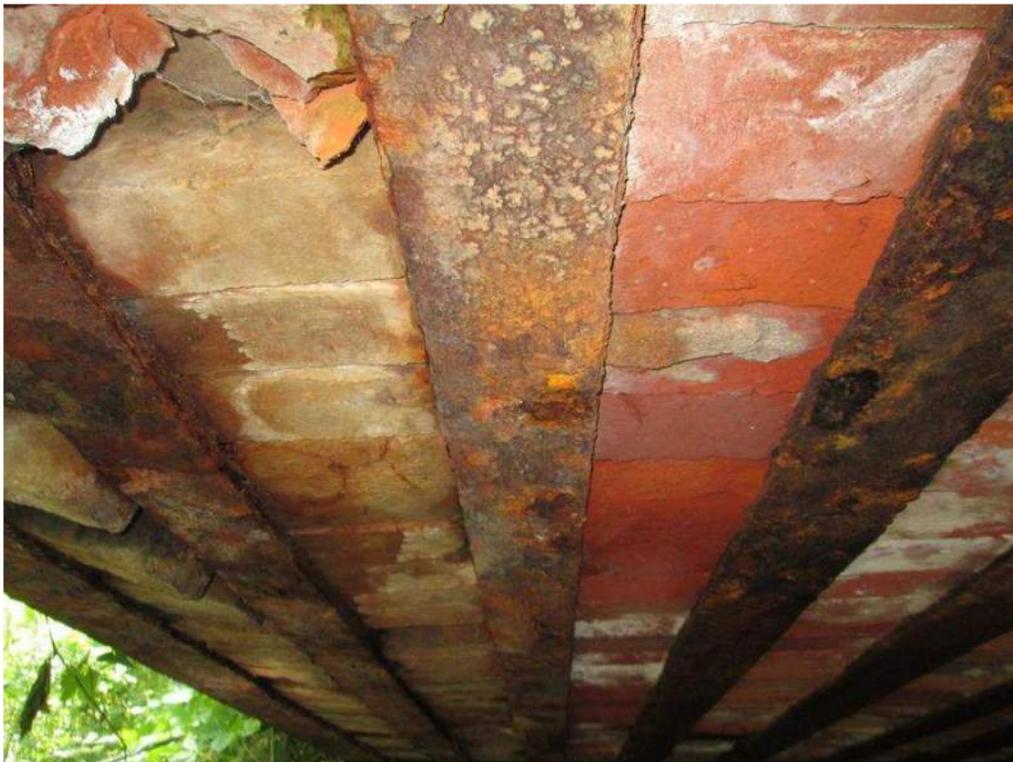
Photo 20: Rail R-18 Bottom Flange Typical Span Heavy Deterioration

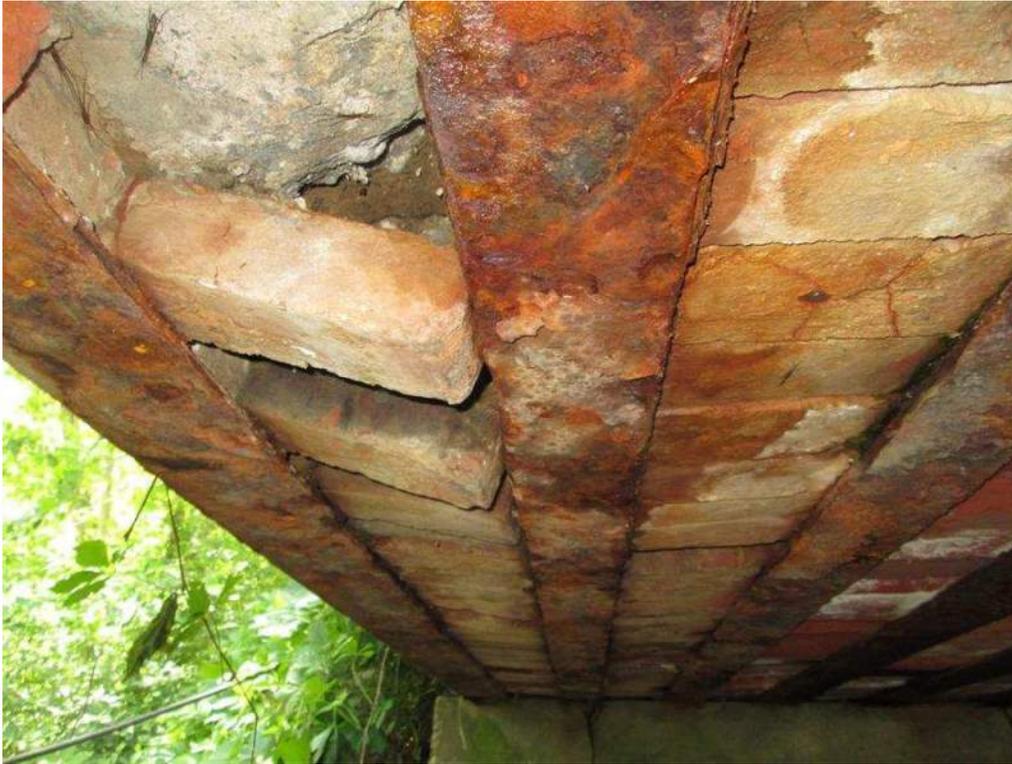
Photo 21: Rail R-19 Bottom Flange Typical Span Heavy Deterioration with Active Leakage

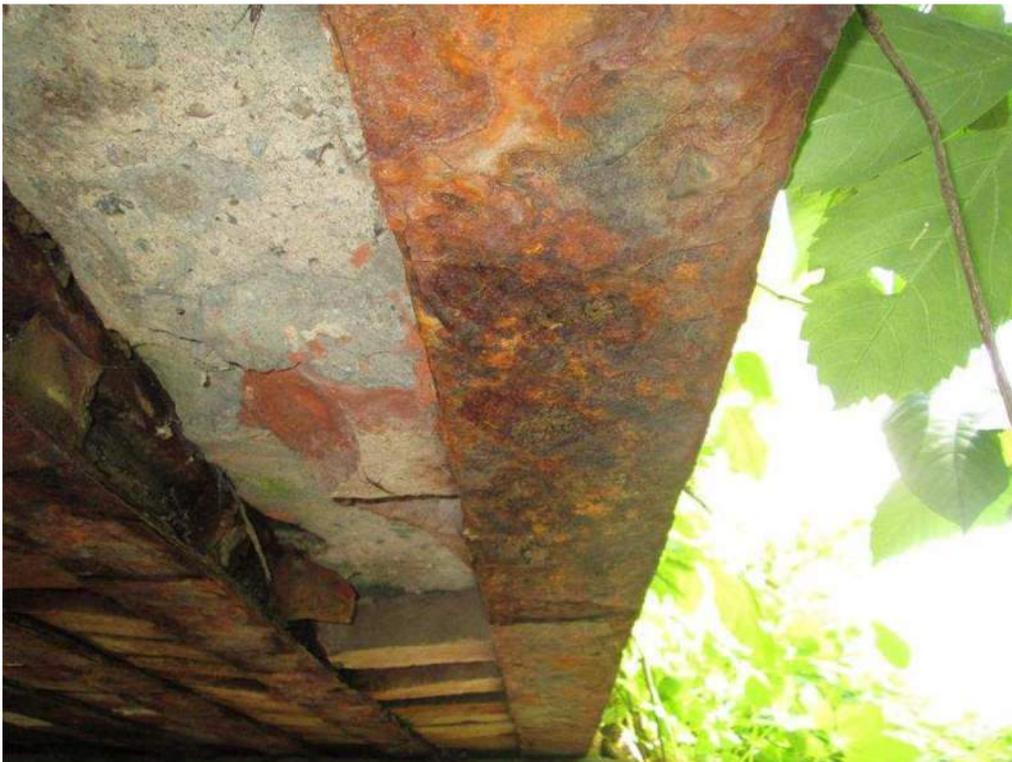
Photo 22: Rail R-20 Bottom Flange Typical Span Heavy Deterioration

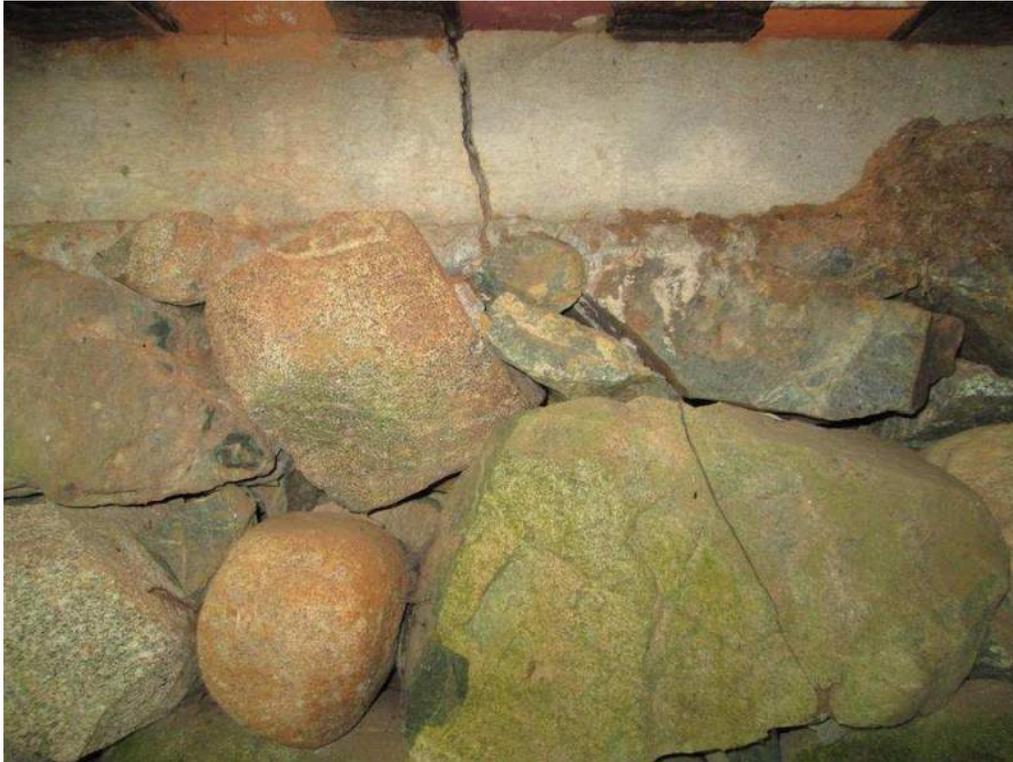
Photo 23: South Abutment Cracked Stone Below Rail R-15

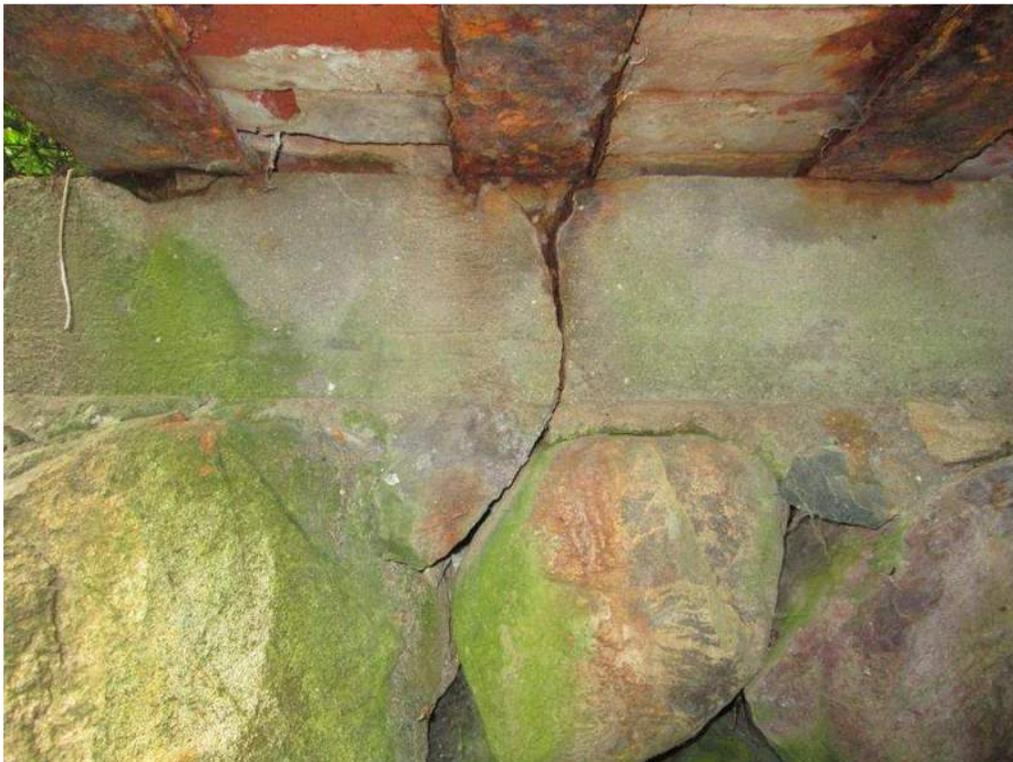
Photo 24: South Abutment Concrete Bridge Seat Full Depth Crack Under Rail R-19

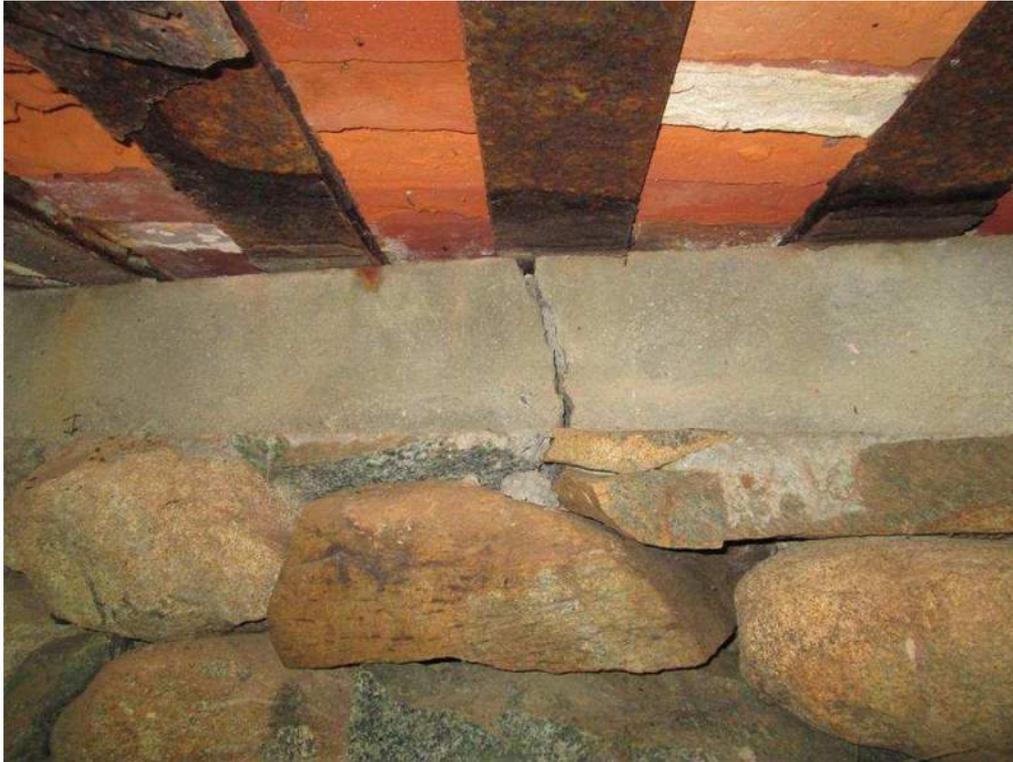
Photo 25: North Abutment Concrete Bridge Seat Crack Below Rail R-8

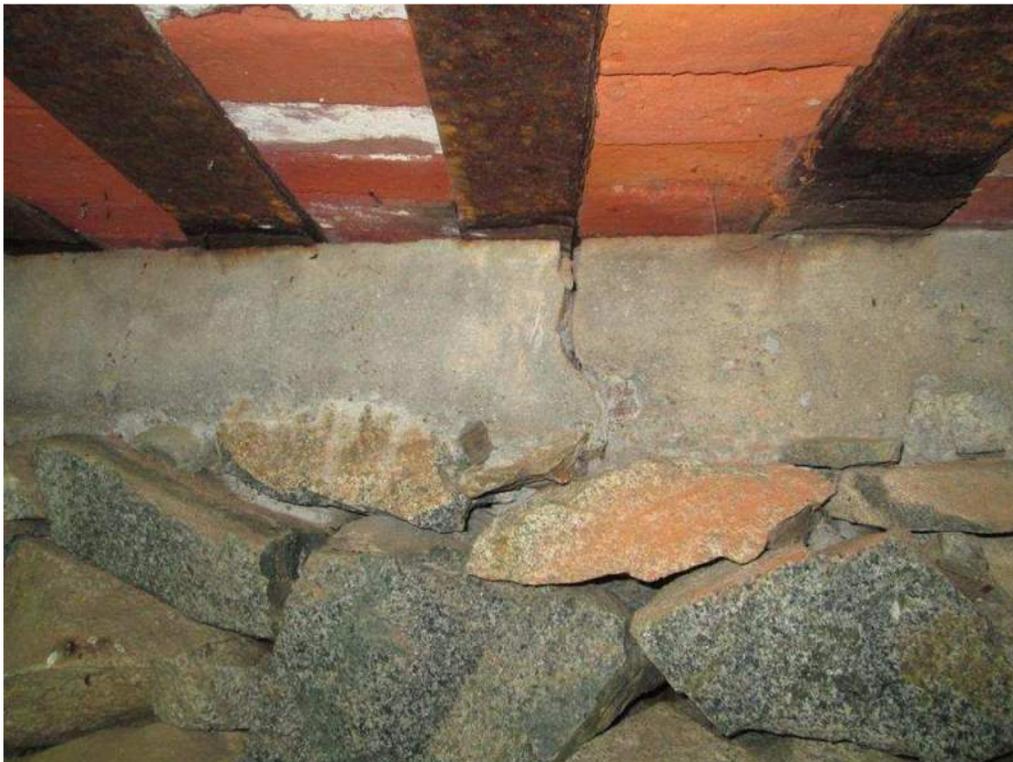
Photo 26: North Abutment Concrete Bridge Seat Crack Below Rail R-13

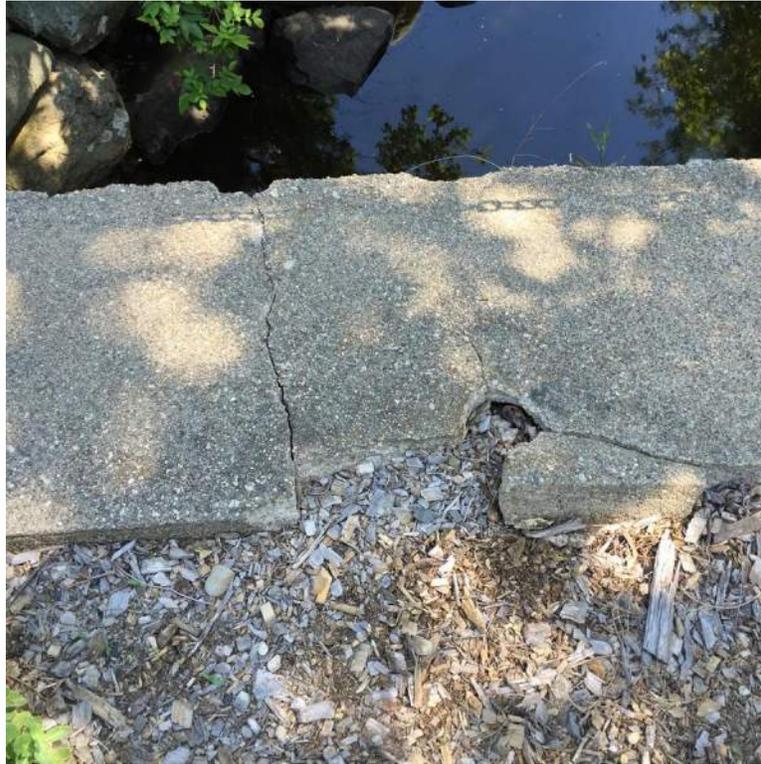
Photo 7: North Bridge Rail Concrete Leveling Pad Deteriorated/Broken Section

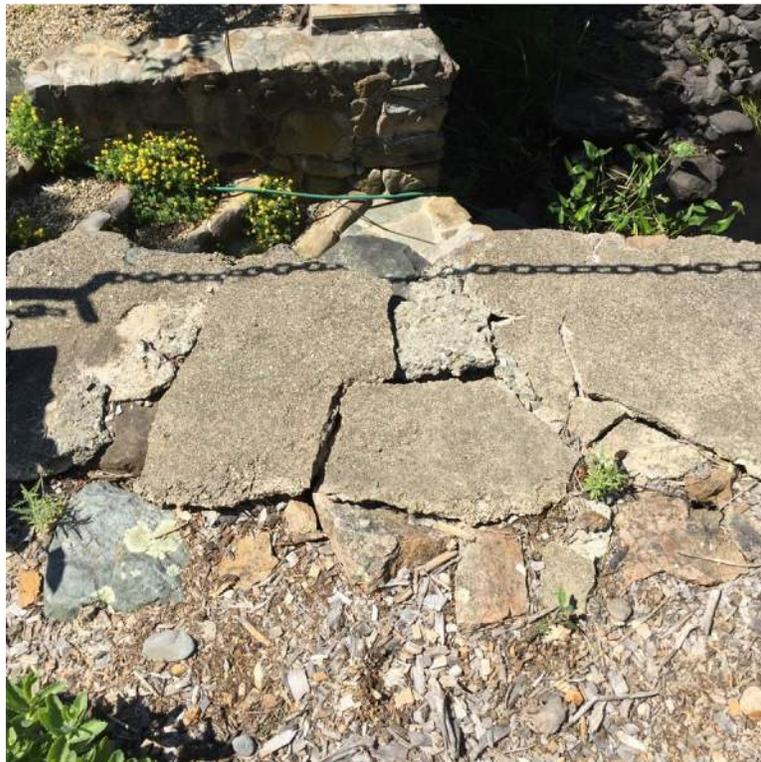
Photo 8: South Bridge Rail Concrete Leveling Pad Deteriorated/Broken Section

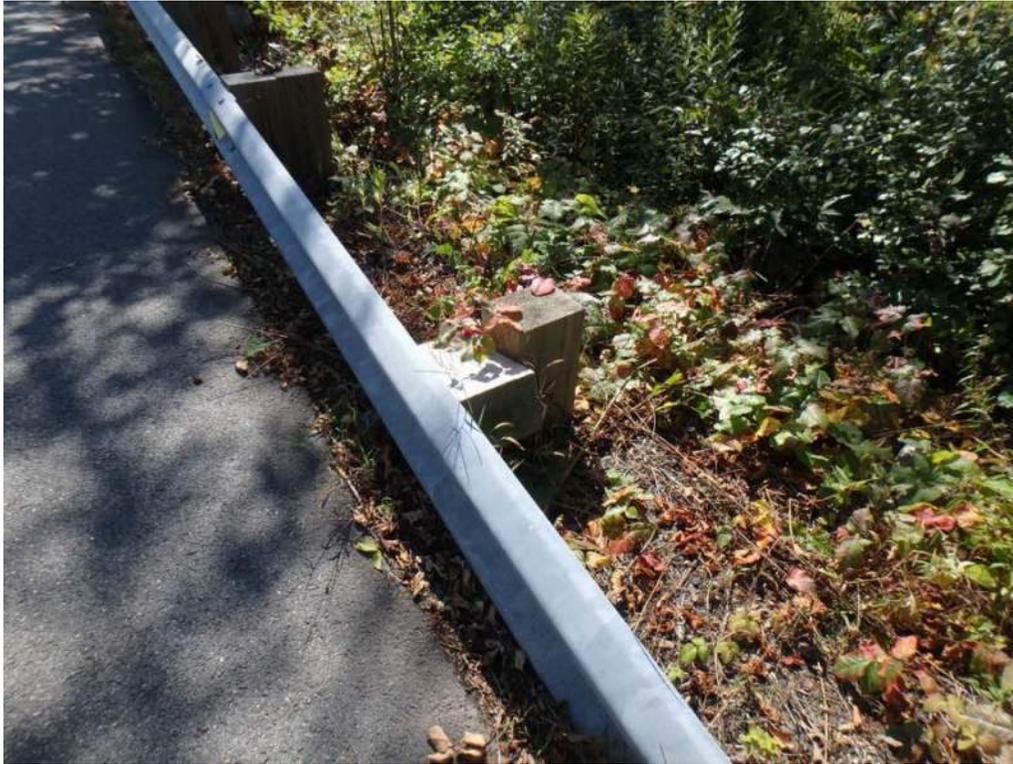
Photo 1: Loose and misaligned guardrail spacer block.

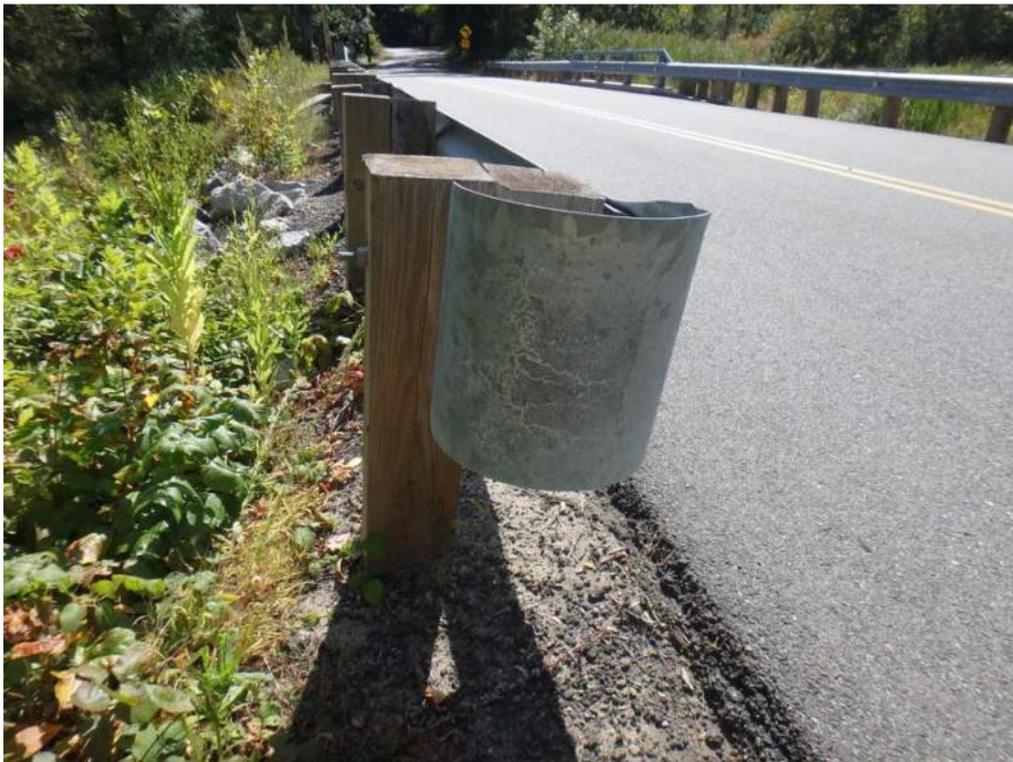
Photo 2: Northwest guardrail end post rotated towards roadway.

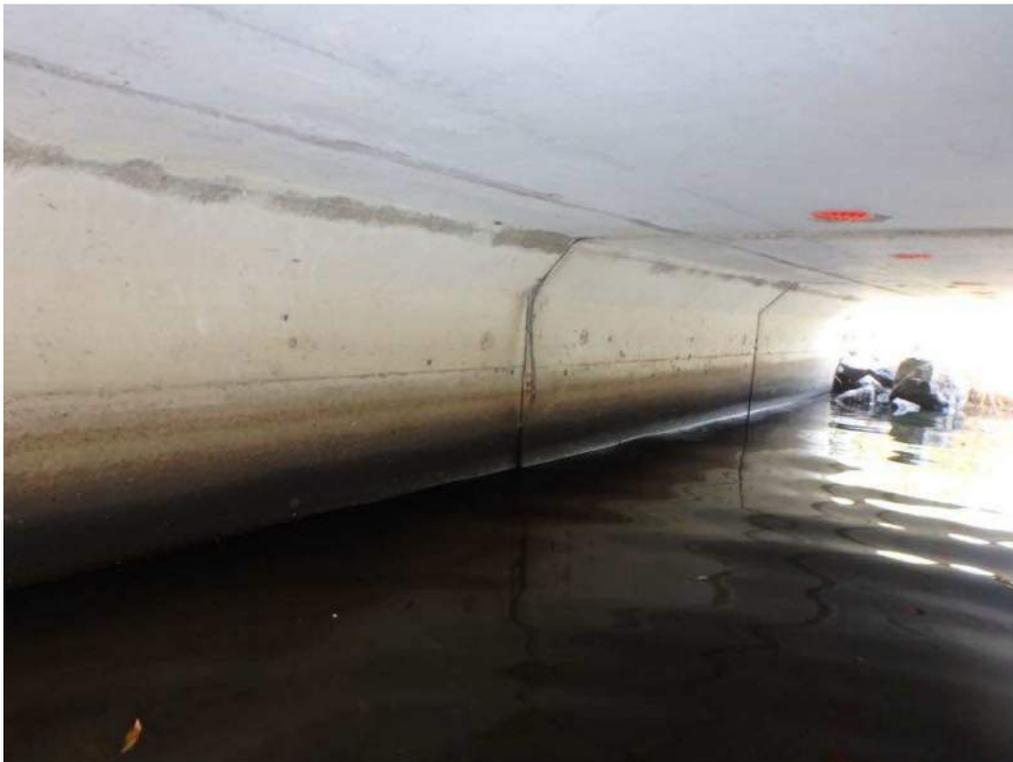
Photo 2: West wall has loose joint filler between rigid frame sections 2 and 3.

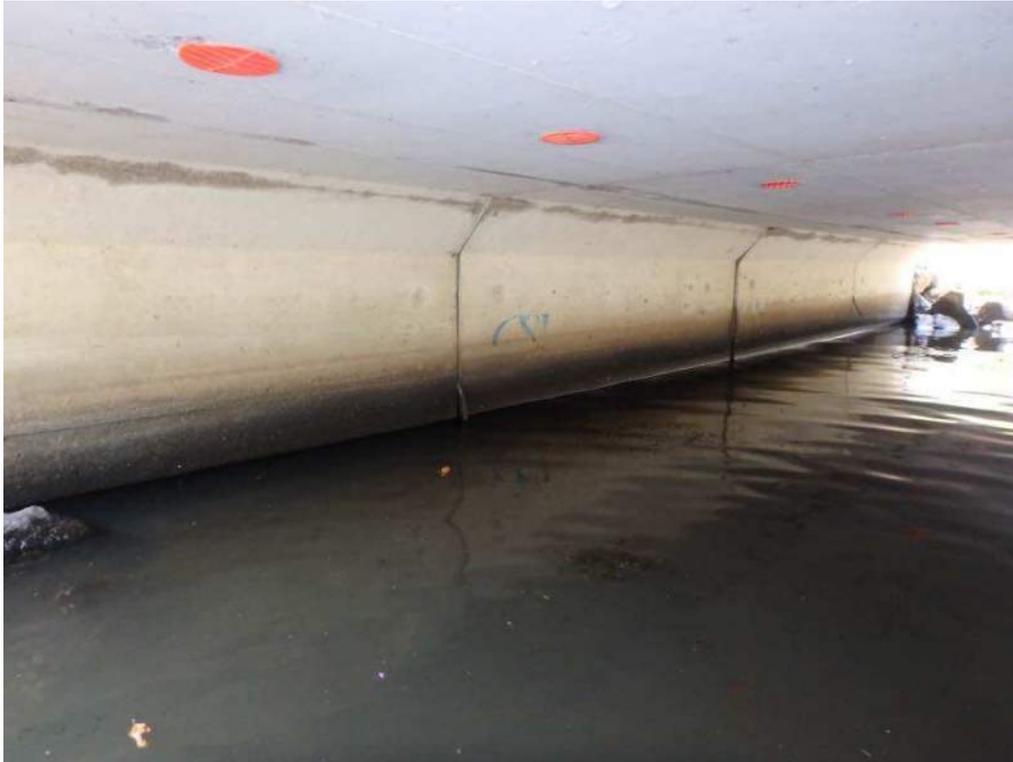
Photo 3: East wall has loose joint filler between rigid frame sections 1 and 2, 2 and 3, and 3 and 4.

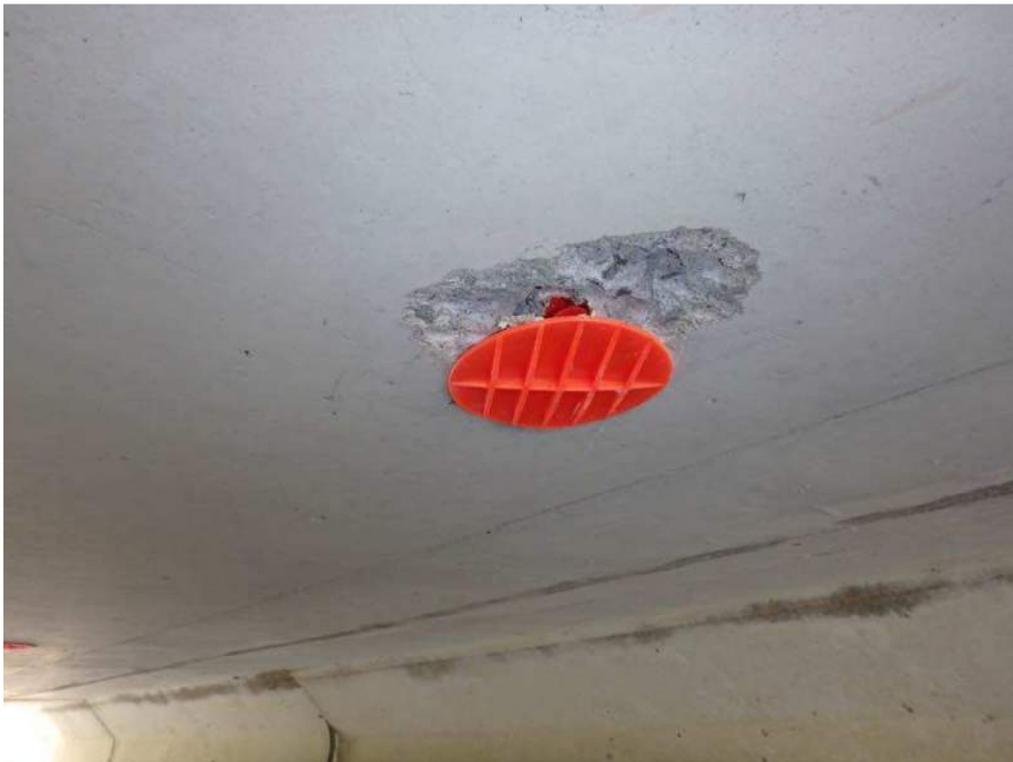
Photo 4: Spall at plastic insert in rigid frame section 3 near north east corner

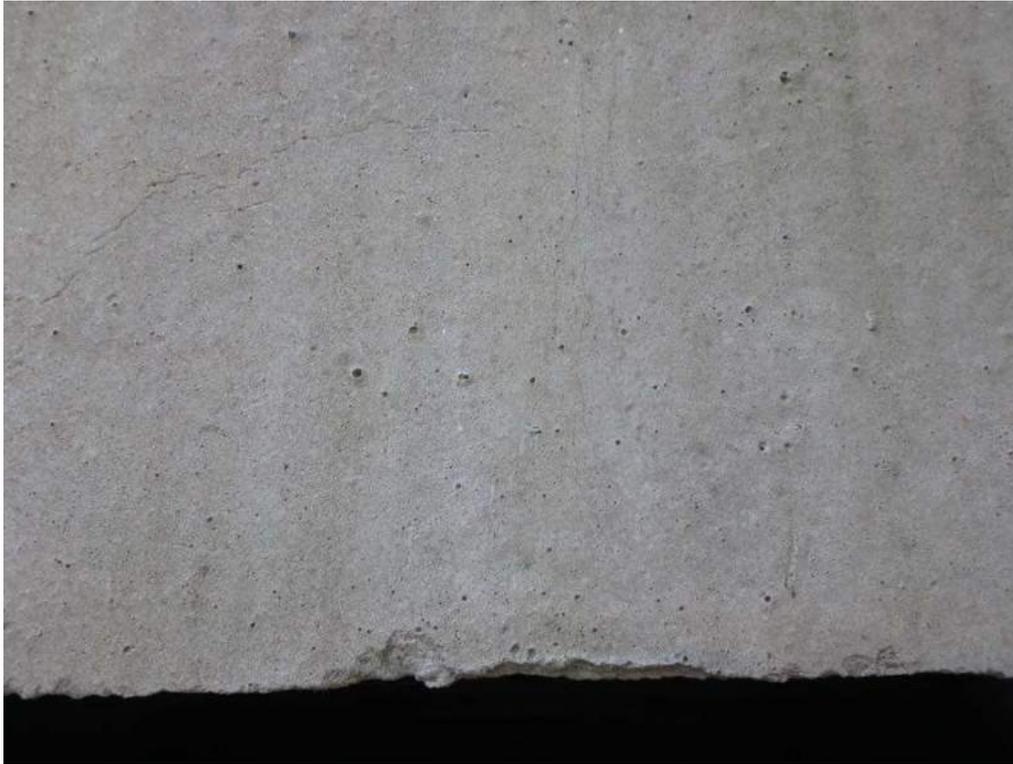
Photo 5: North face of rigid frame section 4 has minor hairline cracks at midspan

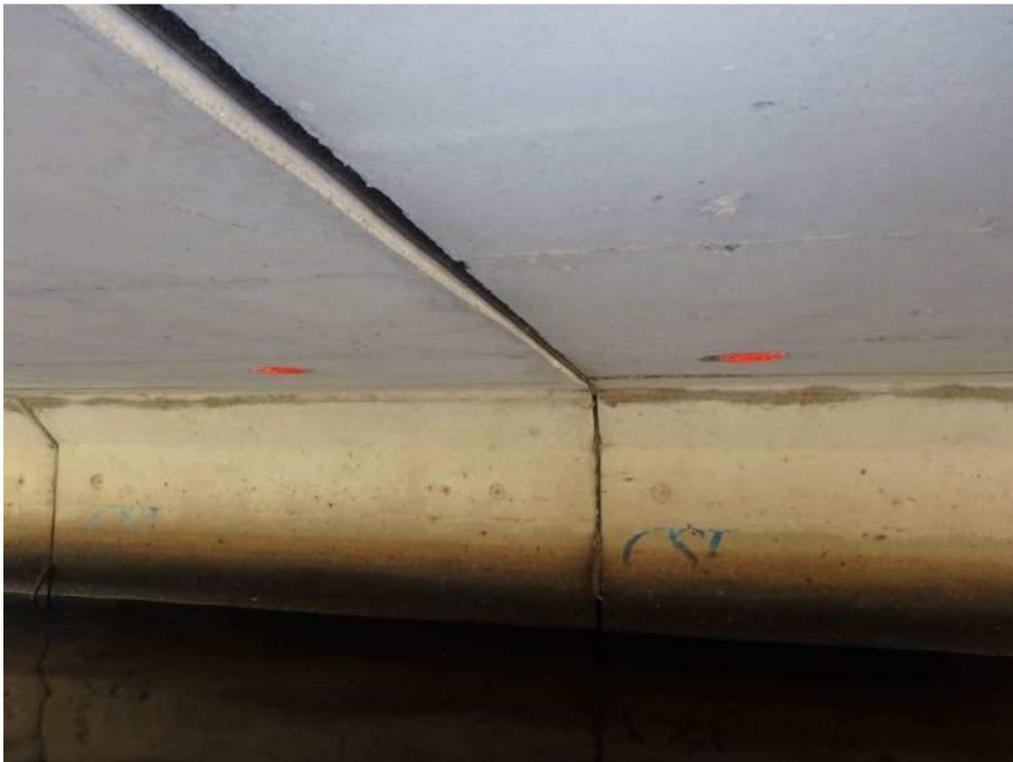
Photo 6: Misalignment of approx. 1/2" at the interface of rigid frame sections 2 and 3 near east wall
